# Manhole Inspection Summary

Manhole # S33GG\_040MH

**Location** Address: **MT ROYAL AVE** Cross Street: **MARYLAND AVE**

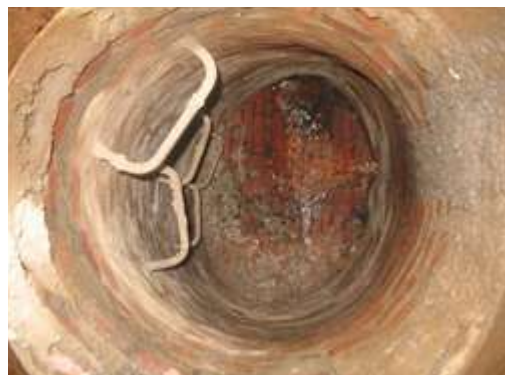
Top View

Channel debris.

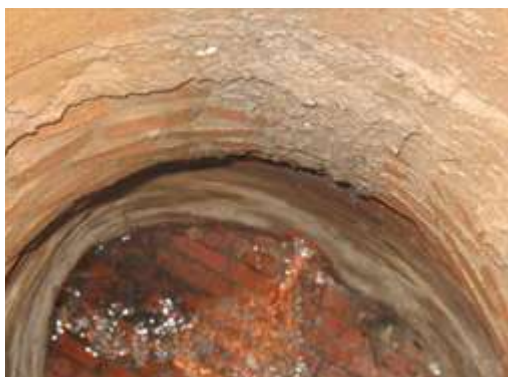
Defect

**Frame** Offset: **0** (in.) Condition: ☐ Sound ☐ Cracked ☒ **Leaks**

Infiltration: ☐ None ☒ **Joint** ☐ Cracks ☐ Mortar ☐ Roots ☒ **Wall**

Infiltration: ☐ None ☐ Joint ☐ Cracks ☐ Mortar ☐ Roots ☒ **Wall**

Frame leaks. Adjustment and Barrel infiltration.

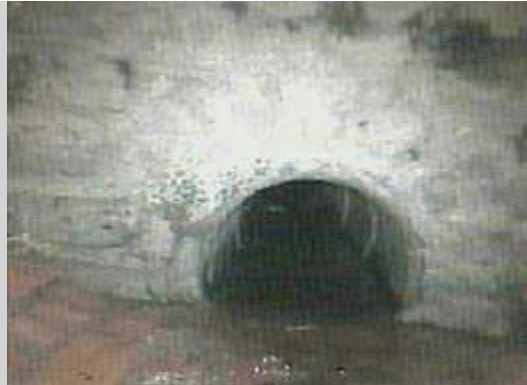
### 8 in. Circular Gravity Sewer Pipe Out @ 12 O'Clock

Infiltration: **Evidence** Pipe Seal Cond: **Unknown**

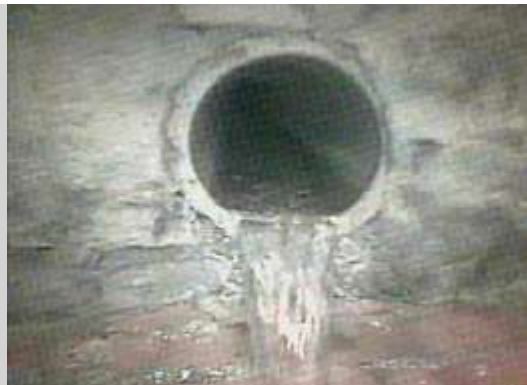
### 8 in. Circular Gravity Sewer Pipe In @ 3 O'Clock

Infiltration: **Evidence** Pipe Seal Cond: **Unknown**
